### A new modular design concept for acoustic arrays

The Norsonic Hextile is a module based approach to acoustic camera that gives the user both portability and great resolution for a wide range of measurement situations. The array dish is based on a hexagon shape, given it both its name, and the ability to combine several tiles into larger systems.

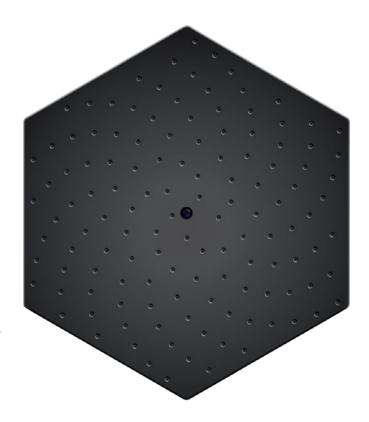
Array geometry and beampattern for Hextile

With a single Hextile, the user has a small, portable and lightweight acoustic camera that can be used for a wide range of measurement situations. The Hextile is a USB based acoustic camera, with a single USB cable for both power and data transfer - no extra battery cable needed. The array is made from robust and lightweight aluminium, has 128 MEMS microphones, and is less than 3 kg in weight while having a maximum diameter of 46 cm. The low frequency limit for the Hextile is 410 Hz.

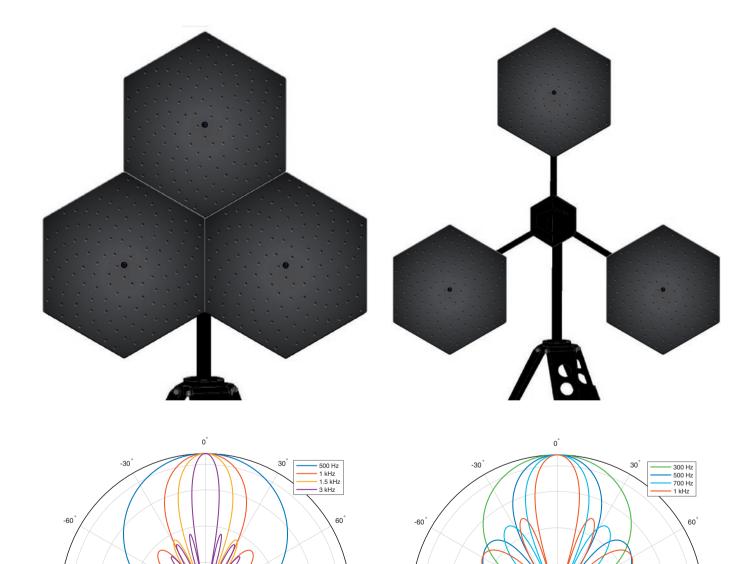
Array geometry and beampattern for Multitile

Array geometry and beampattern for Multitile-LF

For users that require better resolution both in lower frequencies and overall, three single Hextiles can be combined to a larger Multitile system, consisting of 384 microphones with a maximum diameter of 96 cm. The low frequency limit for the Multitile is 220 Hz.

For special low frequency applications below 1 kHz, it is also possible to utilise the Multitile in the low frequency configuration as the Multitile-LF. By placing the individual Hextiles further away, the maximum diameter of the complete array system is increased to 1.46 m, making it ideal for low frequency measurements. The Multitile-LF is for low frequency measurements below 1 kHz, with a lowest frequency limit of 120 Hz.

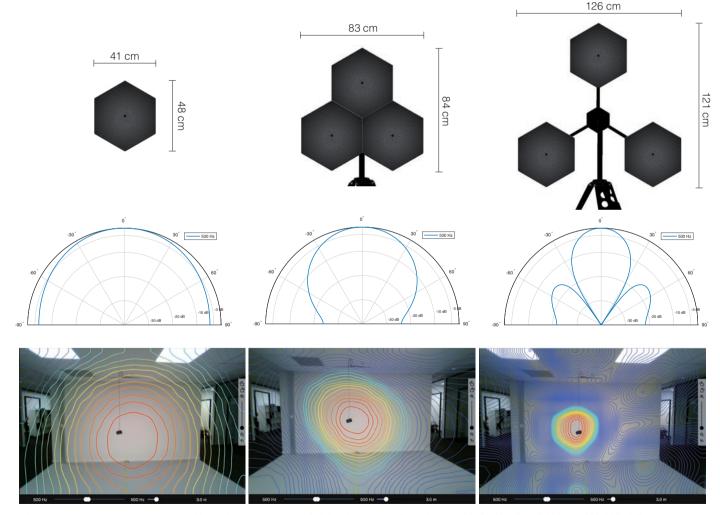
At the top are the different array configurations used for the recordings, with a 128 element Hextile, a 384 element Multitile, and

a 384 element Multitile-LF. The diameters of the array configurations are 46 cm, 96 cm, and 1.46 m respectively.

The second rows show the beampattern for the different array configurations at 500 Hz and 3 dB dynamic range. As can be seen the beampattern gets more narrow, thus giving better resolution, as the overall array size increases.

Lastly the plotting results from the three different array configurations recorded on a real noise source are shown with 3 dB dynamic. The improvement in terms of resolution and pin-pointing the source is clearly visible when using bigger equipment.

Array geometry, beampattern at 500 Hz, and plotting results of pink noise source filtered at 500 Hz for Hextile, Multitile and Multitile-LF

The biggest improvement when going from a single Hextile to the two different Multitile configurations is best demonstrated on a low frequency source. Seen below are the results from recordings on a single omnidirectional noise source emitting pink noise, with the colour plotting being done when the input signals are filtered at 500 Hz. This should give a direct comparison of the low frequency capability of the different arrays.

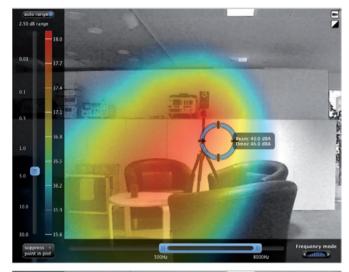
by the stronger source. Seen in the image below is a situation where two equally strong sources are positioned close to one another, and the resulting colour plot will display a single large source. In such situations the acoustic eraser feature may prove valuable. This function will add a red circle to the screen that can be dragged to any point, and remove the source from that point. This is highly effective when several noise sources are present. As seen on the pictures the acoustic eraser completely removes the source where the suppress point button is positioned. The virtual microphone can further be positioned on the source of interest.

Sometimes sources may be closely spaced apart, or a strong noise source in the area of interest is interfering with the recording and impairing the image quality. Often this will be seen as either a single large source, or the source of interest will be completely shadowed

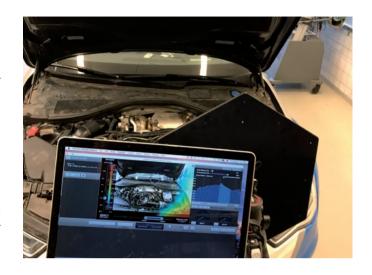
In the spectrogram window, frequency as a function of RPM is plotted. It is further possible to select a square in the spectrogram window to isolate interesting events. By pressing the "apply" button on the selection, the RPM and frequency limits in the main view window automatically change to the limits set by the selection in the spectrogram. The user may then find and interesting sound event in the spectrogram, and automatically get the corresponding colour plotting of the event chosen.

Especially in automotive applications RPM measurements may give vital information. The acoustic camera software has the possibility to display frequency content as a function of RPM by using the order analysis function.

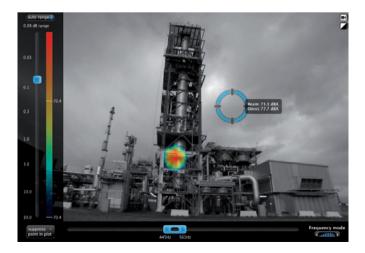
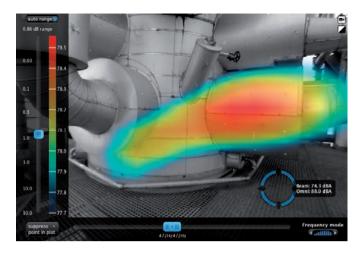
By positioning the center of the array towards the pipe and adjusting the frequency to display only coloring within the 500 Hz 1/3-band, the noise source was located within seconds, and the source producing the tonal part from the pipe was detected. Measurements from different measurement positions also confirmed the source location.

By placing the virtual microphone on the localised source and using the spectrogram function, it was easy to verify the position of the source emitting a tone at 460 Hz.

Based on measurements with hand held sound level meters, the problem area was narrowed down to be a large pipe in the midst of the facility. However it could not be determined if the emitted tonal noise was from the entire pipe itself, or if it originated at a specific part of the pipe. There was also uncertainty whether there existed multiple sources within the pipe, for instance at both the base and top layer. In the worst case the noise insulation would have to be performed over the entire pipe length, which could have been a very expensive solution.

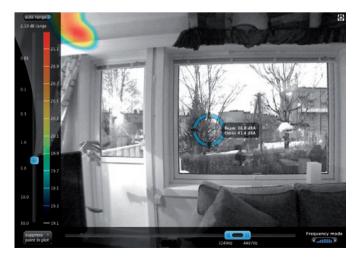
Initial recordings when using traffic as noise source displayed a single strongest facade weakness at the top left of the living room wall. This strongest source position was also confirmed when using the omnidirectional loudspeaker as noise source. At this position a ventilation valve was installed, and most of the traffic noise came from this location.

Having determined that the intake valve was the main noise contributor, this spot was covered up with a pillow to remove it from the overall noise field, and try to locate secondary sources. By filtering on a relatively high frequency band around 3 - 4 kHz, it was possible to filter out only the noise being emitted by small gaps and cracks. This produced two new possible weaknesses, one on the porch door, and another on the air valve above the window.

In addition to using traffic as noise source, measurements were made by placing a omnidirectional loudspeaker emitting white noise on the outside of the facade. This created a more stationary sound field on the outside of the structure, and made detection of small cracks and gaps in the structure even easier.
